INDOOR AIR QUALITY ASSESSMENT

**Bryantville Elementary School
29 Gurney Drive
Pembroke, MA**

Prepared by:
Massachusetts Department of Public Health
Bureau of Environmental Health
Indoor Air Quality Program
October 2017

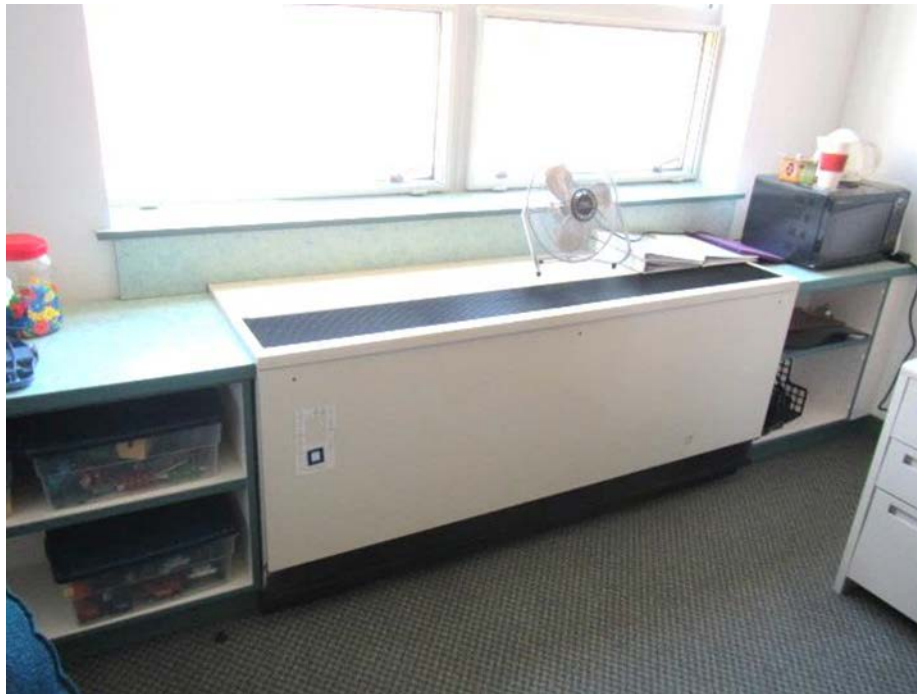
Picture 1

Fresh air is provided by a combination of unit ventilators (univents) located in individual classrooms (Picture 1) and air handling units (AHUs; Picture 2), which serve central areas such as the gym, library and office areas. The unit ventilators draw fresh air through a vent on the exterior wall (Picture 3). Air is mixed with return air from the room, filtered, heated (if needed) and delivered to the room (Figure 1). Air from the AHUs is filtered, heated or cooled as needed, and delivered to rooms via ducted supply vents (Picture 4).

Classroom unit

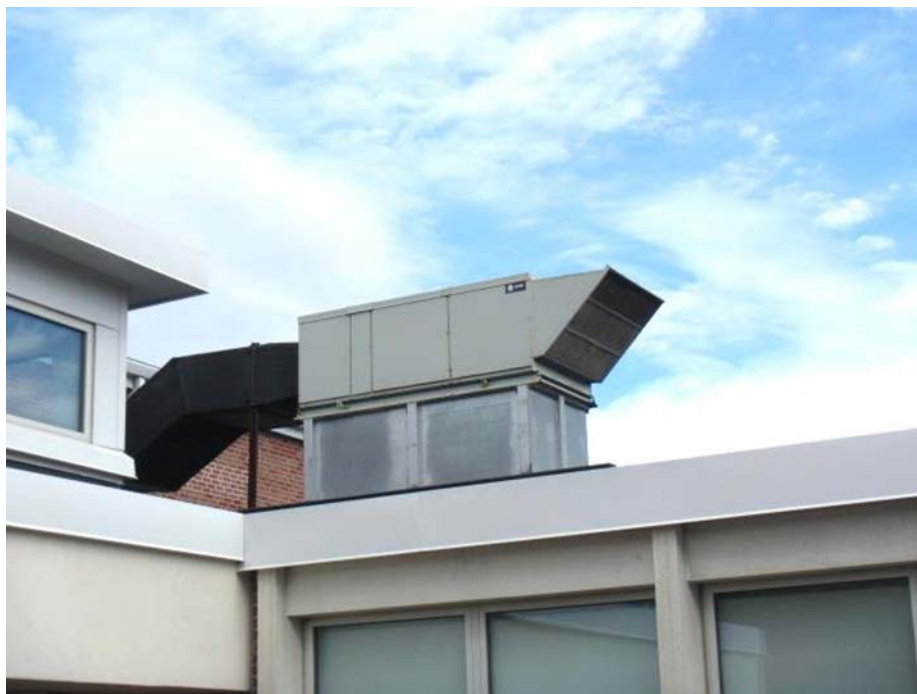
Picture 2

Rooftop air handling unit

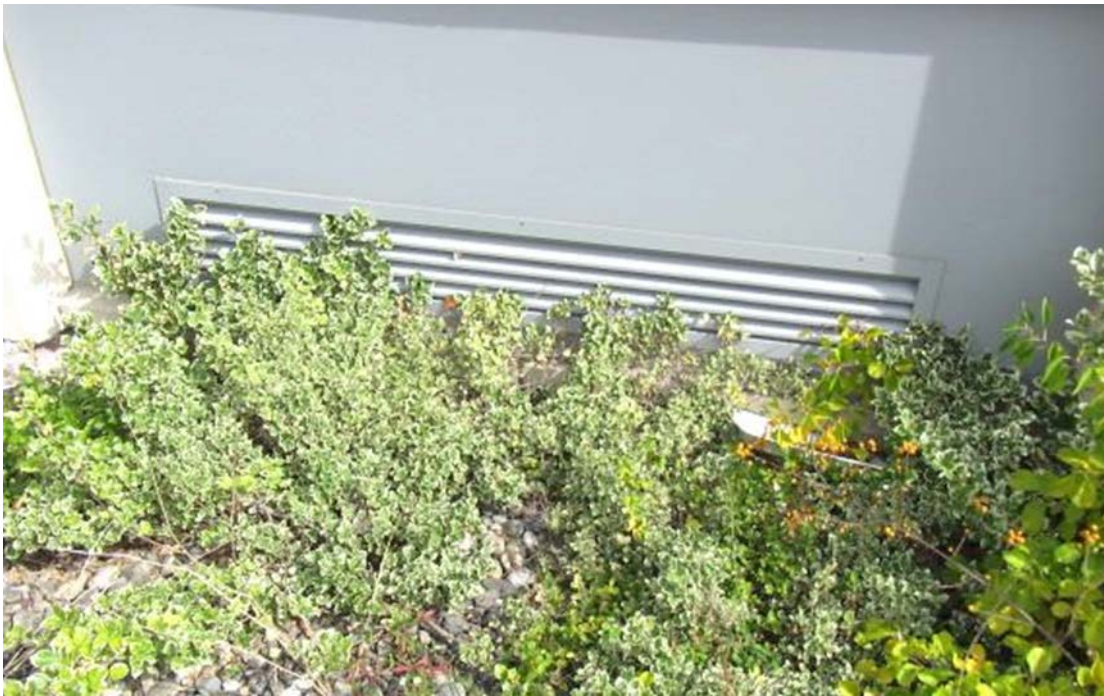
Picture 3

Univent fresh air intake, note plants/shrubbery

8. Ensure roof and plumbing leaks are repaired and replace water-damaged ceiling tiles.
9. Ensure plants, trees and shrubs are located at least five feet away from exterior walls/foundation of the building in both courtyards and around the exterior of the building.

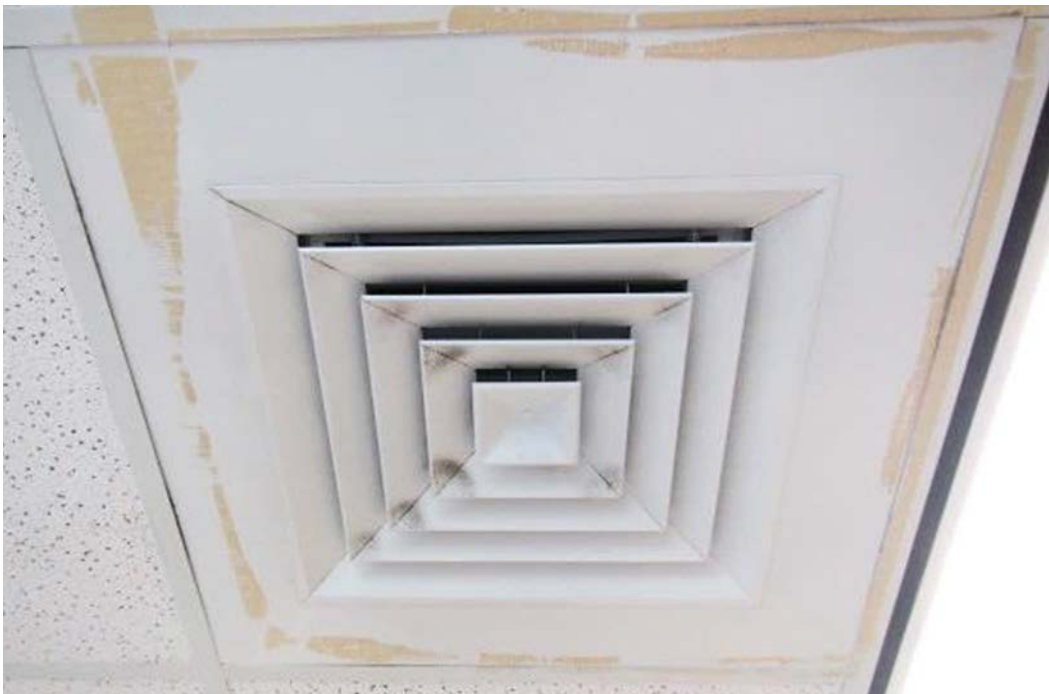
Picture 4

Many classrooms had personal fans. Some of these had dusty blades (Picture 16; Table 1). Some supply diffusers (Picture 4) and exhaust vents were also observed to be dusty. This dust can be reaerosolized when the equipment is activated. In many areas, items, including books, papers, toys and decorative items were observed on floors, windowsills, tabletops, counters, bookcases, and desks (Picture 17; Table 1), which can make it more difficult for custodial staff to clean.

Ceiling-mounted supply diffuser, note dust/debris on louvers

17. Regularly clean/vacuum univent cabinets, supply/return vents and fans to avoid aerosolizing accumulated particulate matter. Consider using compressed air to loosen/remove accumulated dust/debris in hard to access univent grills/cabinets, and then vacuum with a HEPA vacuum cleaner.

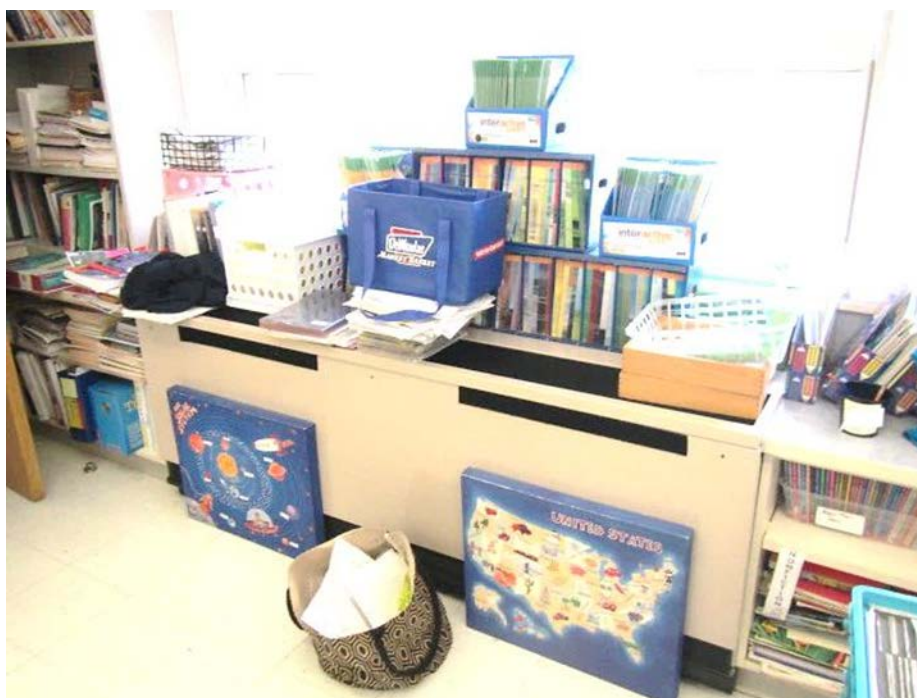
Picture 5

It was reported that univents operate under an automated/energy efficiency management system and cycle off/on according to the set point of the thermostat, which deactivates the HVAC system when it reaches a preset temperature, therefore, no mechanical ventilation is provided until the thermostat reactivates the system. To maximize air exchange, the MDPH recommends that both supply and exhaust ventilation operate *continuously* during periods of occupancy. In addition, many univents were obstructed by items placed on top or in front (Pictures 5 and 6). Both the top and the vent at the bottom need to be kept clear of obstructions for the units to operate as designed.

Items on univent/front of return vent (bottom/front)

3. Remove items and furniture blocking univents both on top and along the front.
4. Check exhaust vents for draw periodically and repair any non-operating vents.

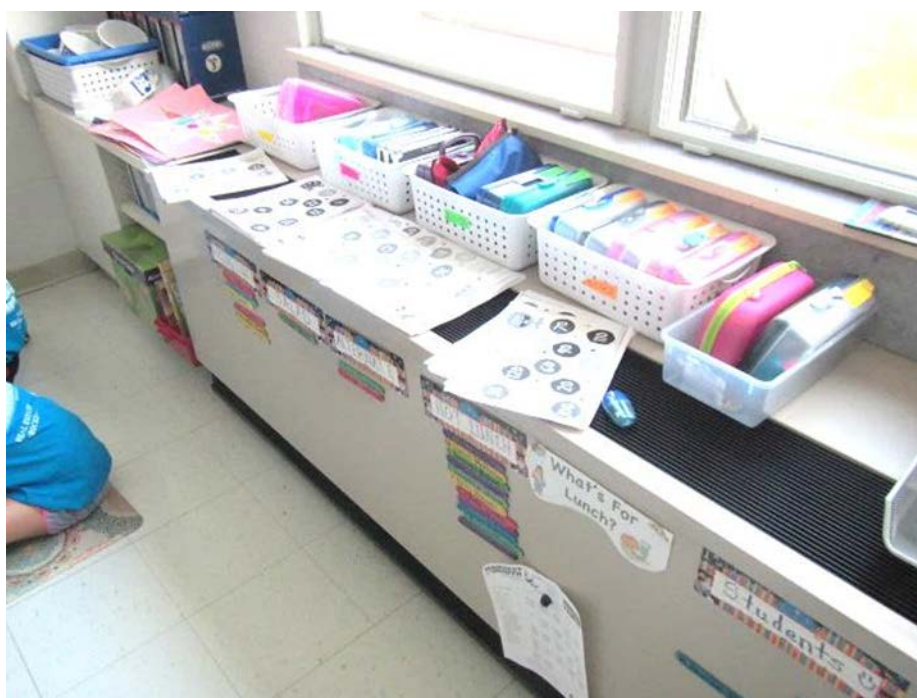
Picture 6

Items on top of univent air diffuser

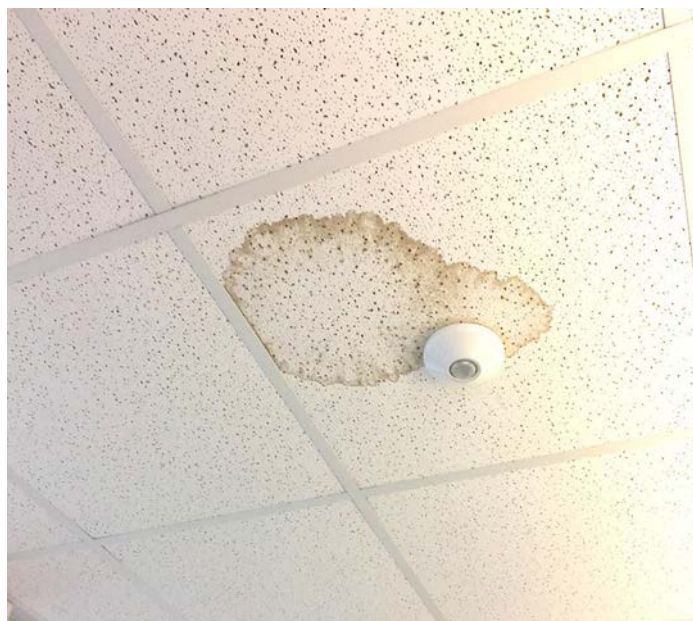
Picture 8

Water-damaged ceiling tiles were observed in a few areas (Picture 8; Table 1), which indicate leaks from the building envelope or plumbing system. These tiles should be replaced after the leak is found and repaired. It was reported that roof repairs had recently been conducted to prevent further leaks.

Water-damaged ceiling tile

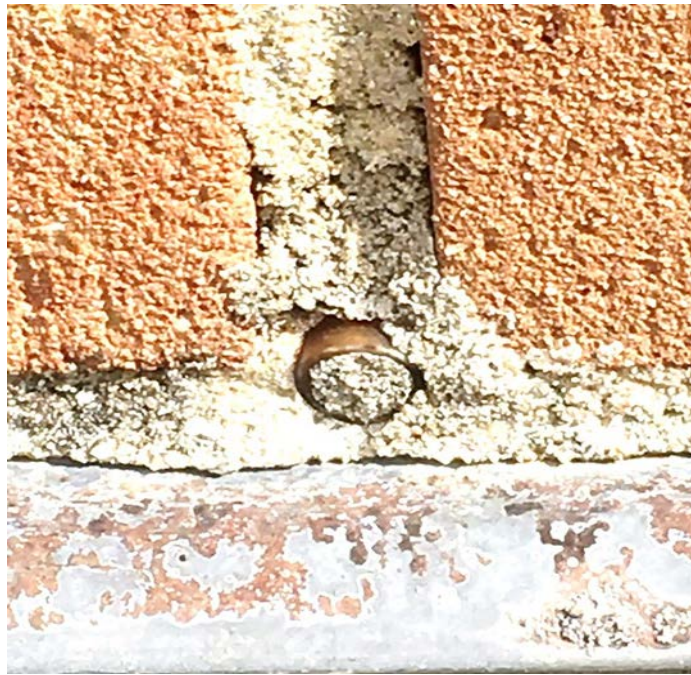
Picture 9

The exterior of the BES consists of a traditional red brick exterior wall. An examination of brick walls was conducted (along the exterior and in courtyards) to identify the location and condition of weep holes. Weep holes were found approximately at the slab level. Of note is that many weep holes were blocked with debris (Picture 9) or buried, which prevents water drainage from the exterior wall system.

Blocked weep hole

10. Remove blockages from all weep holes and clear obstructions to walls to maximize water drainage from exterior wall systems.
11. Properly maintain plants, including drip pans, to prevent water damage to porous materials. Plants should also be located away from air diffusers to prevent the aerosolization of dirt, pollen, and mold.

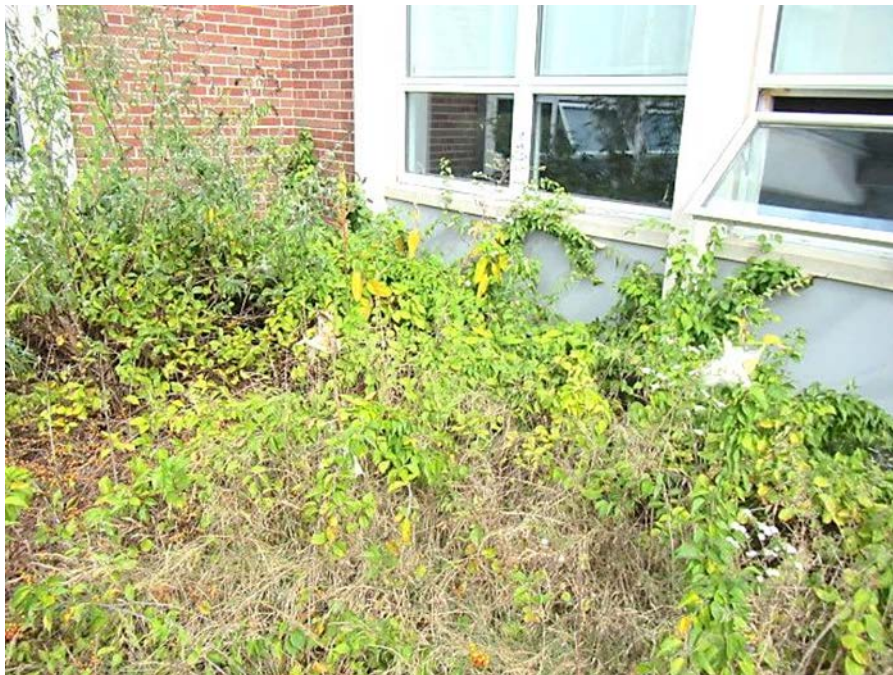
Picture 10

The school is built around four courtyards which are severely overgrown with trees, shrubbery and other plants (Pictures 10 and 11). Trees were also observed overhanging the roof in some areas (Picture 12). These conditions can lead to deterioration of the building envelope due to root infiltration and dampness against exterior walls/foundation. Plants can also be a source of moisture, debris and pollen drawn into air intakes. Plants/trees should be trimmed away from the building and from overhanging the roof to prevent clogging of roof drains/gutters.

Courtyard overgrown with plants/shrubbery

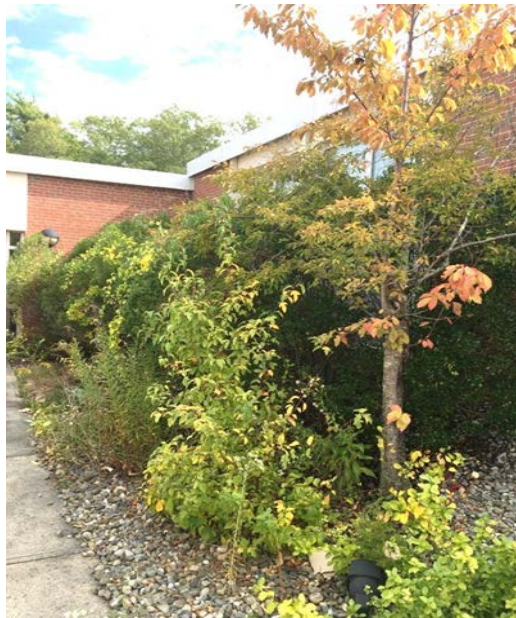
Picture 11

Courtyard overgrown with trees, plants and shrubbery

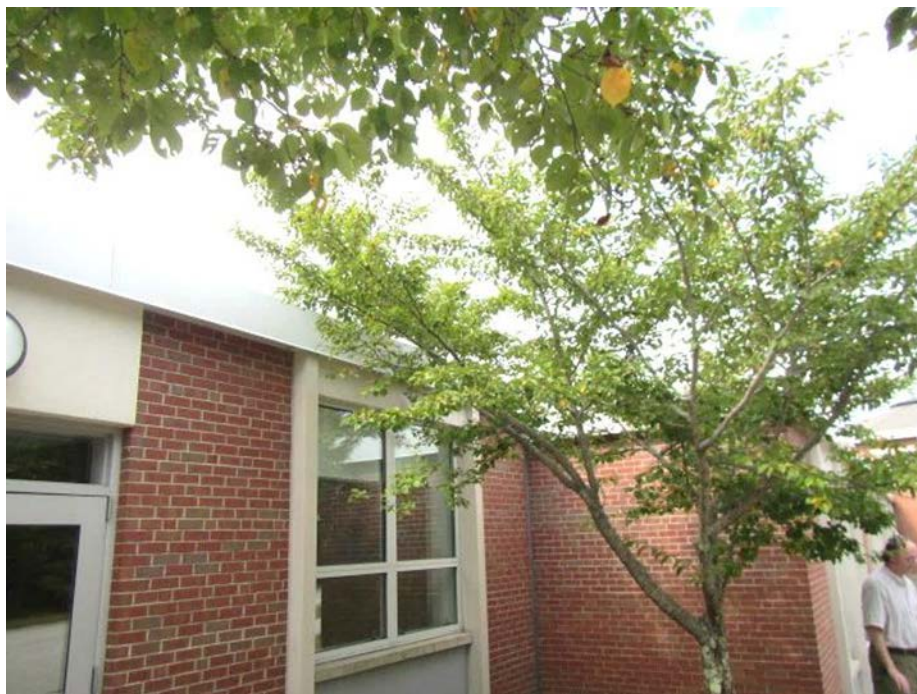
Picture 12

Trees overhanging roof

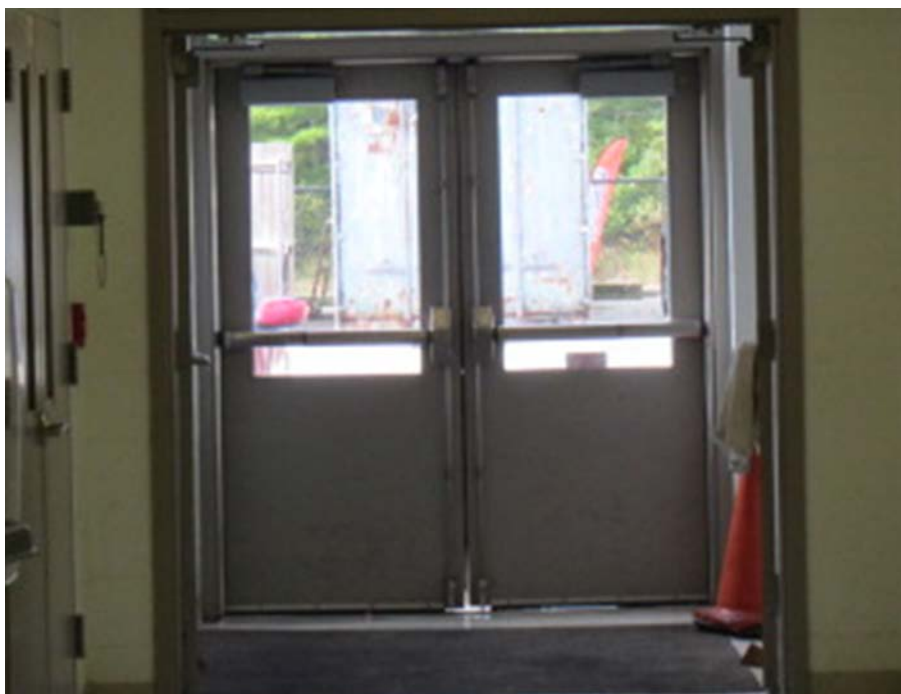
Picture 13

Light could be seen beneath the exterior door to entrance #3 (Picture 13). The exterior was examined and found to have a missing/damaged door sweep (Picture 14), which can provide a pathway for moisture, drafts and or pests into the building.

Light penetrating beneath doorway #3

12. Replace missing/damaged sweeps on exterior doors. Ensure tightness by monitoring for light penetration around doors.
13. Reduce use of products and equipment that create VOCs; only use in well-ventilated areas.

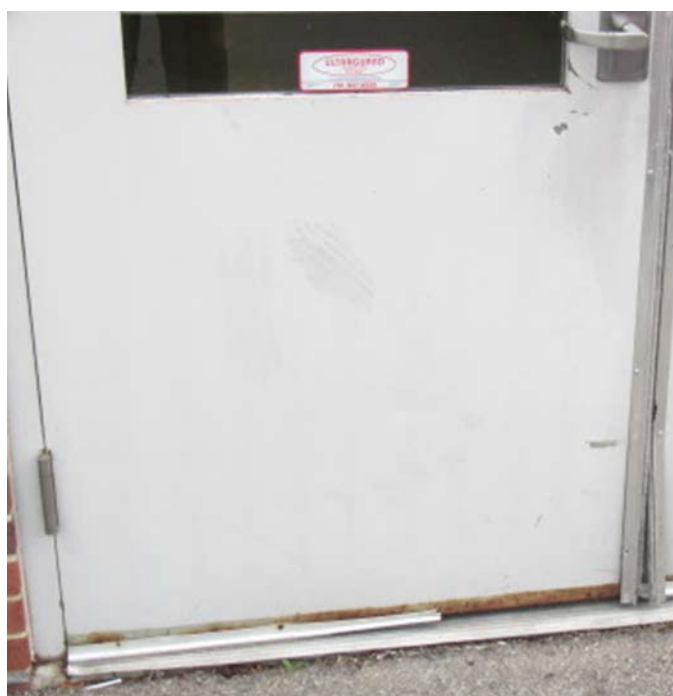
Picture 14

Missing/damaged door sweep

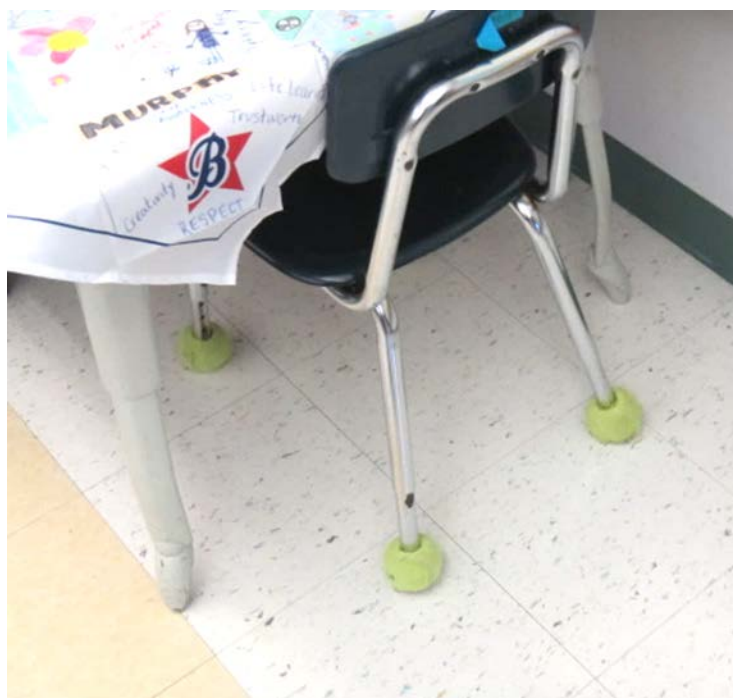
Picture 15

In a few areas, tennis balls had been sliced open and placed on chair footings to reduce noise (Picture 15). Tennis balls are made of a number of materials that are a source of respiratory irritants. Constant wearing of tennis balls can produce fibers and lead to off-gassing of VOCs. Tennis balls are made with a natural rubber latex bladder, which becomes abraded when used as a chair leg pad. Use of tennis balls in this manner may introduce latex dust into the school environment. Some individuals are highly allergic to latex (e.g., spina bifida patients) (SBAA, 2001). It is recommended that the use of materials containing latex be limited in buildings to reduce the likelihood of symptoms in sensitive individuals (NIOSH, 1997; NIOSH, 1998).

Tennis balls on chair legs

14. Keep spray bottles/cleaning products out of the reach of children (e.g., in cabinets over sinks).
15. Replace tennis balls on chair footings with latex-free glides.

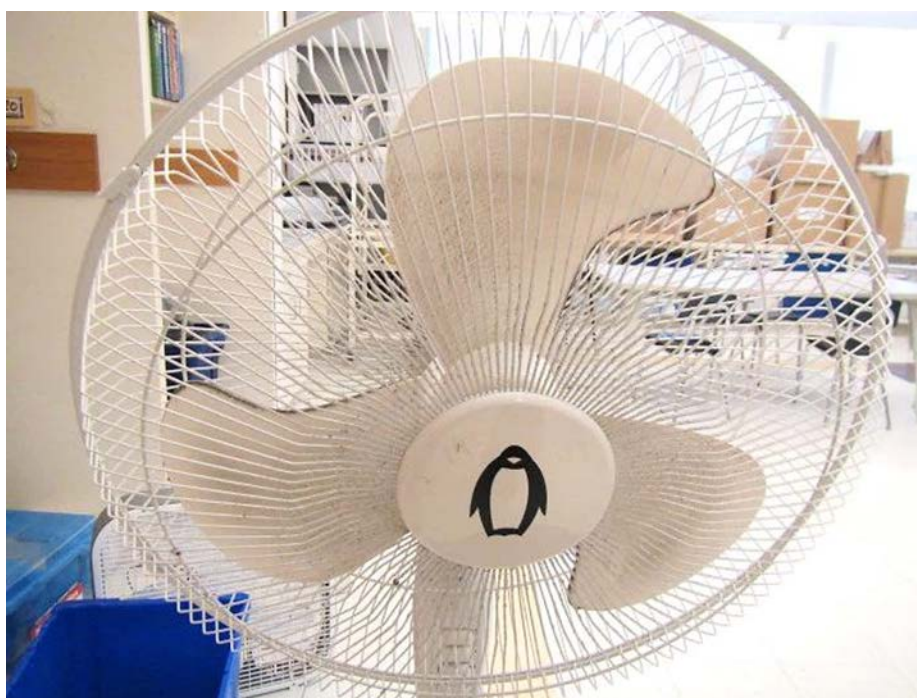
Picture 16

Accumulated dust/debris on fan blades

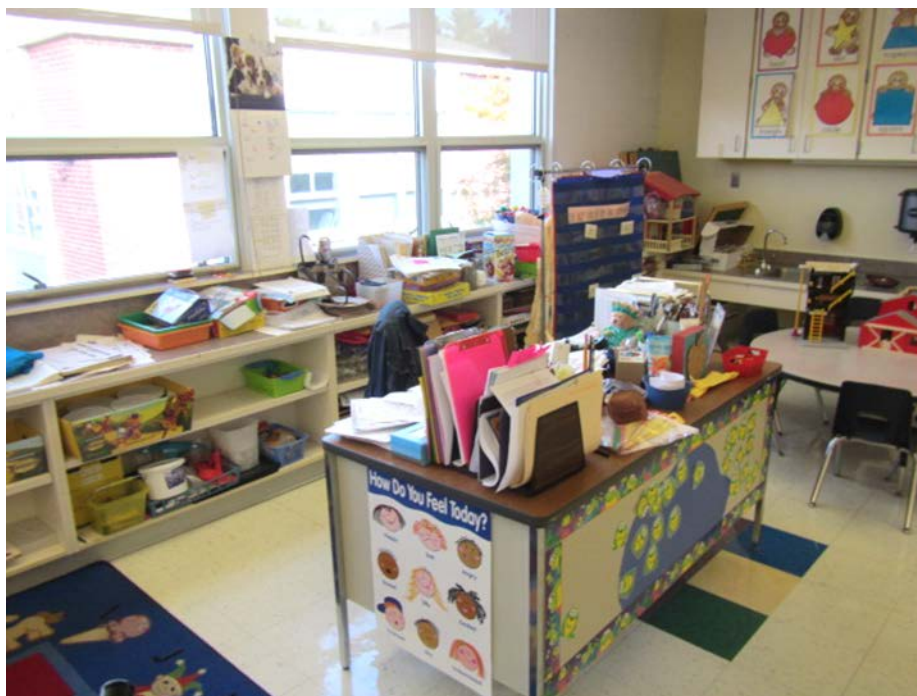
Picture 17

Accumulated items on flat surfaces

18. Clean window-mounted air conditioner filters prior to the start of the cooling season and according to the manufacturer's instructions.
19. Consider reducing the amount of items stored in classrooms to make cleaning easier. Periodically move items to clean flat surfaces.
